South Porch / South Aisle  
(Looking South)

client Horningsea PCC	job title Porch Access & QI Repairs	<b>Freeland Rees Roberts Architects</b> 25 City Road, Cambridge CB1 1DP 01223 366555 info@frrarchitects.co.uk			
drawing title Photosheet (2 of 3)	scale nts	size A3	drawn hf/ej	date Jan 2020	drawing no. <b>19.055 - SK - 05</b>
					rev -

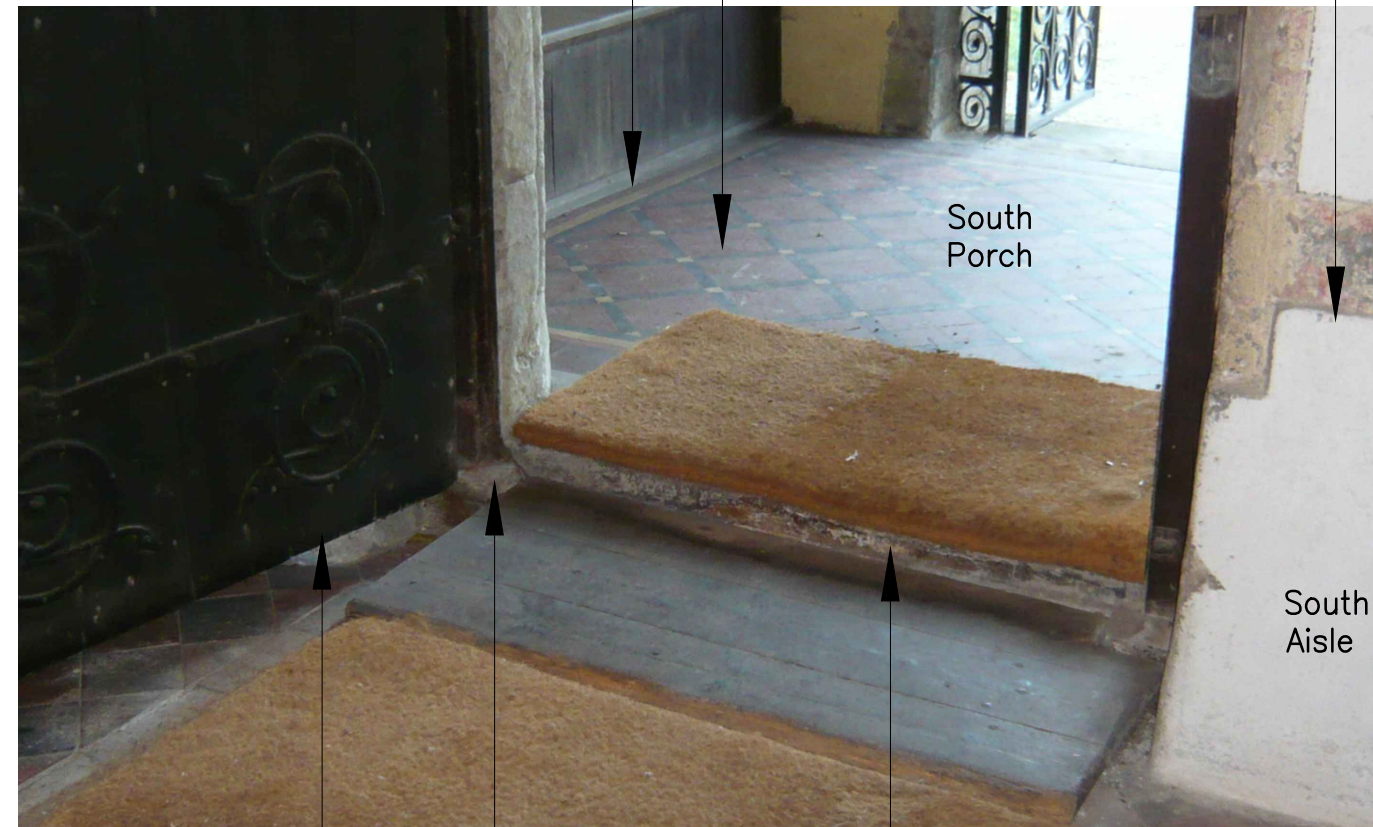
floor of the porch is to be rebuilt

- 2.4** The floor of the porch is to be rebuilt so that it is level with the outside of the new threshold under the door into the south aisle. The new porch floor level will be 25mm above the south aisle floor level.

- 2.6** At the side walls there is boarding up to the level of the benches. It is not clear whether this is all boxed out from the wall or whether it conceals a thickened wall base. Proceed as follows:

provide new timber skirting in height to suit the lowered floor

allow for minor repointing/making good to stone joints to plaster and door jambs/reveals

carefully alter and extend the bottom of the door in oak decorated to match existing to suit the lowered threshold

retain the mouldings of the jambs at low level

carefully remove existing threshold stones to the doorway and provide and install a new shaped threshold at the lower level to match the south aisle floor level

- 2.5** Build the new floor of the porch with breathable geotextile layer, 100 mm thick foam glass insulation, second geotextile layer, fibre reinforced lime concrete slab 100mm thick and re-used Victorian tiles bedded on and pointed in lime mortar. Assume for pricing that the floor goes under the side bench seats.

- a) Investigate
  - b) If the seat is hollow, dismantle and retain for reuse. Proceed to replace the floor including under the seats and reinstate at the same level but extending the support framing and adding a deeper skirting.

- c) If the seat is not hollow, retain but remove sufficiently to carry out the work to the floor and then reinstate the seating, boarding and skirting.

- 2.7** Carefully remove the existing threshold stones to the doorway into the South aisle retaining the mouldings to the jambs as low level, lower the waling beneath and provide and install a new shaped threshold at the lower level to match the south aisle floor level.

- 2.8** Where the threshold has been lowered, review the details at the bottom of the jambs and allow for some working in to allow the door with its extension downwards, to open.

- 2.9** Take off the door into South aisle, alter, and extend the bottom of the door in oak decorated to match existing to suit the lowered threshold.
- 2.10** Allow a provisional sum of £250 for additional work to the bottoms of the door jambs.

- 2.11** Allow for overhauling /easing the existing ironmongery. Allow provisional sum for minor repointing/making good to stone joints to plaster and door jambs/reveals.
